# Manhole Inspection Summary

Manhole # S21E\_\_024MH

Insp Date: **10/16/07 10:03 AM**

**Location** Address: **255 SARATOGA ST**

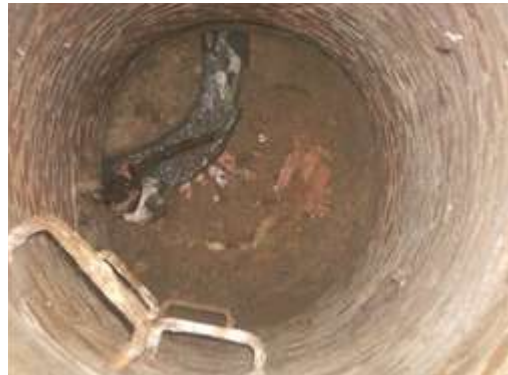
Top View

Comments **huge pole in channel could not move from topside, we got best picture that we could**

DEBRIS IN CHANNEL AND ON BENCH

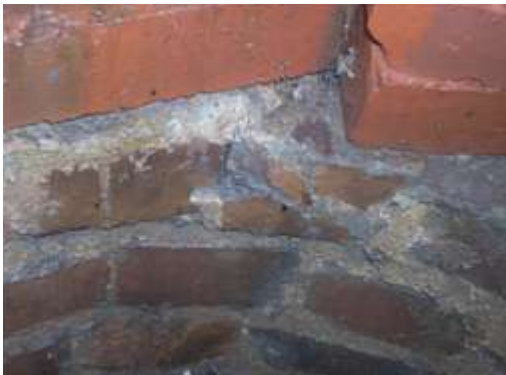
Defect 6

**Corbel** Material: **Brick** ☐ Parged Type: **Concentric/Eccentric**

Condition: ☐ Sound ☐ Cracked ☐ Root Intrusion ☐ Loose Brick ☒ **Deteriorated**

DETERIORATED CORBEL

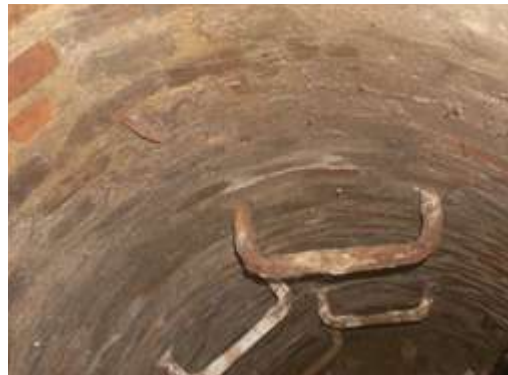
Defect 5

**Steps** Count: **4** Missing: **1** ☒ **Corroded**

CORRODED AND MISSING STEPS

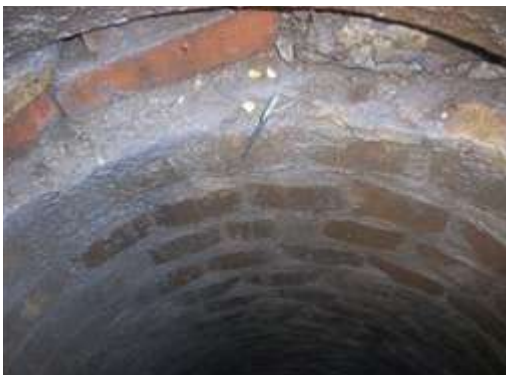
Defect 4

Infiltration: ☐ None ☒ **Joint** ☐ Cracks ☐ Mortar ☐ Roots ☐ Wall

JOINT INFILTRATION

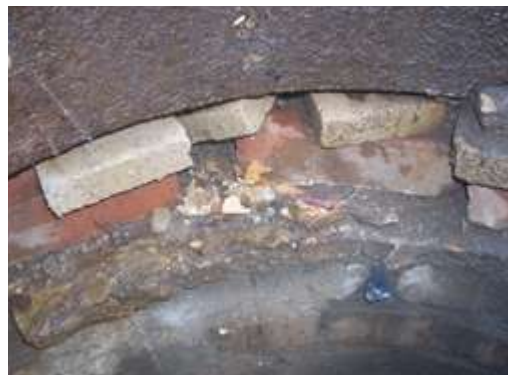
Defect 3

**Chimney / Frame Adjustment** ☒ Exists Material: **Brick and Stone** ☐ Parged Height: **6** (in.)

Condition: ☐ Sound ☐ Cracked ☐ Root Intrusion ☐ Loose Brick ☒ **Deteriorated**

DETERIORATED CHIMNEY

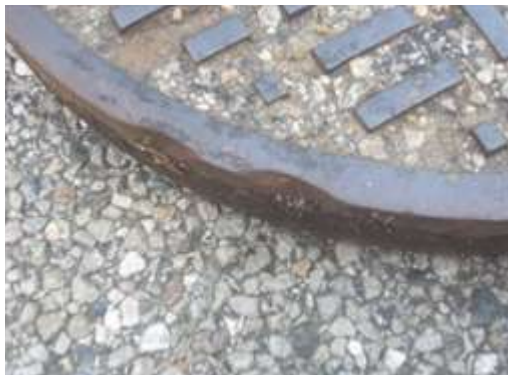
Defect 2

Type: **Sanitary** Condition: **Worn** Cover Material: **Cast Iron**

WORN COVER

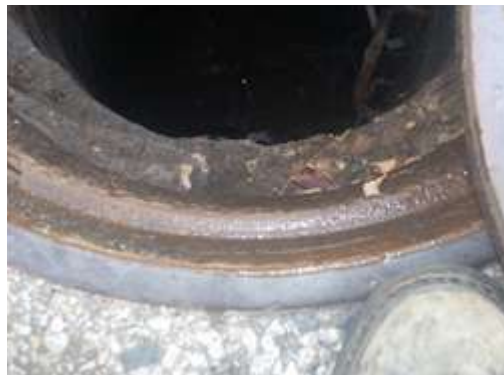
Defect 1

**Frame** Offset: **3** (in.) Condition: ☒ Sound ☐ Cracked ☐ Leaks

FRAME OFFSET

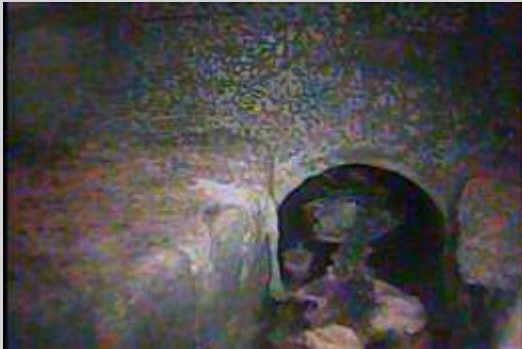
12 O'Clock Outflow

8 in. Circular Gravity Sewer  
Pipe Out @ 12 O'Clock

Pipe Height: **7.2** (in.) Rod and Bar (Angled)  
Pipe Material: **Clay** ☐ Pipe Lined  
Invert Depth: **11.72** (ft.) Flow Characteristics: **Slow**  
Deposits: ☐ None ☐ Mud ☐ Sludge ☒ **Debris** ☐ Grease  
Silt Depth: **2** (in.) Deposits Extent: **Light**  
Infiltration: **None** Pipe Seal Cond: **Sound**

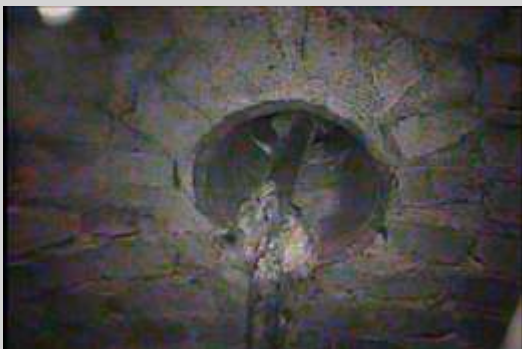
9 O'Clock Inflow

DETERIORATED CORBEL

Pipe Height: **7.2** (in.) Rod and Bar (Angled)  
Pipe Material: **Clay** ☐ Pipe Lined  
Invert Depth: **9.01** (ft.) Flow Characteristics: **Slow**  
Deposits: ☐ None ☐ Mud ☐ Sludge ☒ **Debris** ☐ Grease  
Silt Depth: **1** (in.) Deposits Extent: **Light**  
Infiltration: **None** Pipe Seal Cond: **Sound**

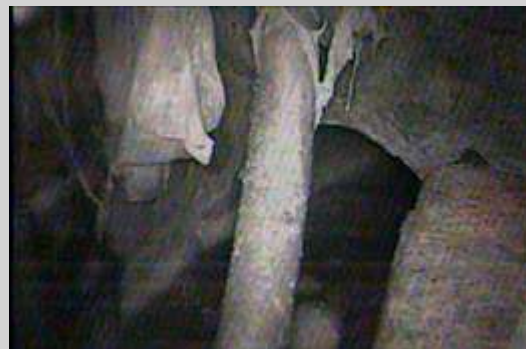
Drop In @ 9 O'Clock

DETERIORATED CORBEL

Drop: **Outside** Rod and Bar  
Angled: **Yes** Reading: **10.41** (ft.)  
Inv Depth: **11.41** (ft.)  
Drop Condition: **Open**
